**BISHOP TUBE SITE
LITTLE VALLEY CREEK SURFACE WATER AND SPRING MONITORING**

SAMPLING EVENT REPORT

Prepared by
Dustin A. Armstrong
Project Officer

August 27, 2003

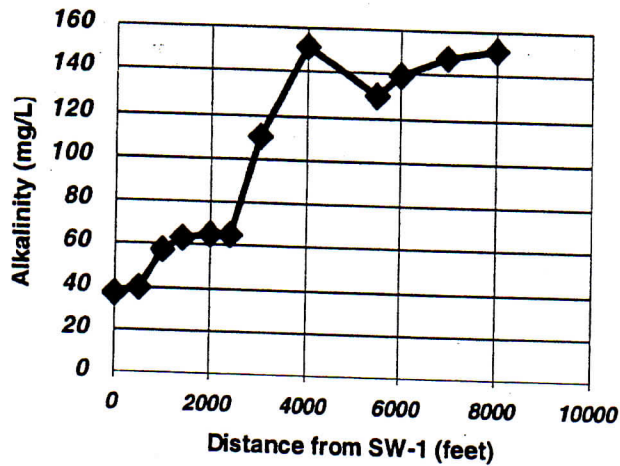
Chart 2 – May 2003 Little Valley Creek
Total Alkalinity Concentration vs. Downstream Distance
Between Bishop Tube Site and Worthington Steel Site

Chart 2 reveals that alkalinity generally increases downstream of the site. The only downward trend occurs between SW-10 and SW-15. This decrease is likely the result of the contribution of the Morehall tributary in this stream segment. Total alkalinity was reported at 86.3 mg/L in a sample from the Morehall trib just above its confluence with Little Valley Creek. Most notably areas with the maximum alkalinity increases were between SW-2 and SW-3 and between SW-8 and SW-10. Increasing alkalinity in these areas indicates that groundwater may be discharging to Little Valley Creek along the eastern site boundary and between Conestoga and Morehall Roads. Since groundwater in these areas is known to contain elevated concentrations of TCE, it is anticipated that in-stream TCE concentrations would increase in these areas. Chart 3 depicts the alkalinity levels shown in Chart 2 (in mg/L) and TCE concentrations (in ug/L)

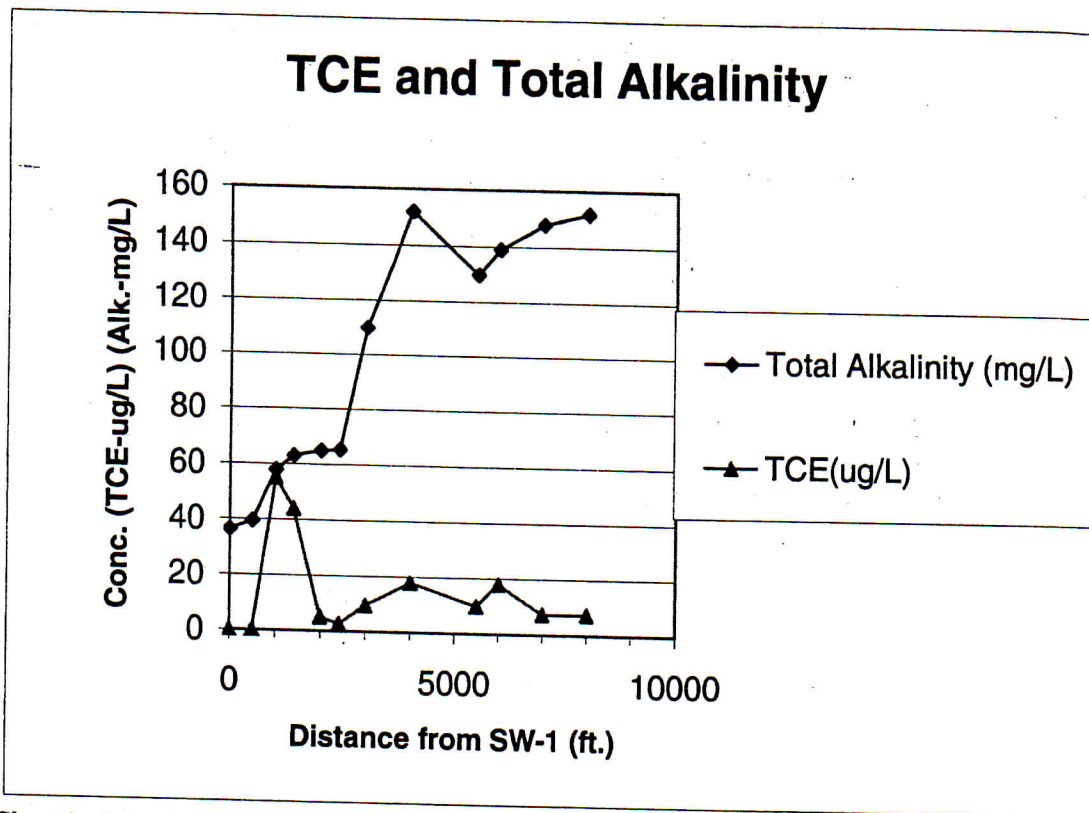
Chart 3 – May 2003 Little Valley Creek
 Total Alk. (mg/L) and TCE (ug/L) Concentrations vs. Downstream Distance
 Between Bishop Tube Site and Worthington Steel Site

Chart 3 depicts a strong relationship between alkalinity and TCE concentrations in Little Valley Creek. The link seems to be the strongest adjacent to the site (between SW-2 and SW-3). This is not surprising, given that the groundwater in this vicinity is highly contaminated by TCE. Two other areas of increasing TCE levels should also be noted. Between Conestoga Road (SW-8) and above Morehall Road (SW-10) alkalinity rises significantly and TCE concentrations also increase. Similar corresponding increases in alkalinity and TCE levels are apparent between SW-15 and SW-16. Interestingly, water from a large spring (SP-4) enters the creek between these locations. In-stream TCE concentrations due to groundwater discharge would be expected to vary depending on the makeup and source of the discharging water. The geologic complexity of the underlying formation makes it difficult to link contaminants to any one source. This is especially true in the case of a contaminant such as TCE, which is one of the most ubiquitous contaminants found in groundwater.

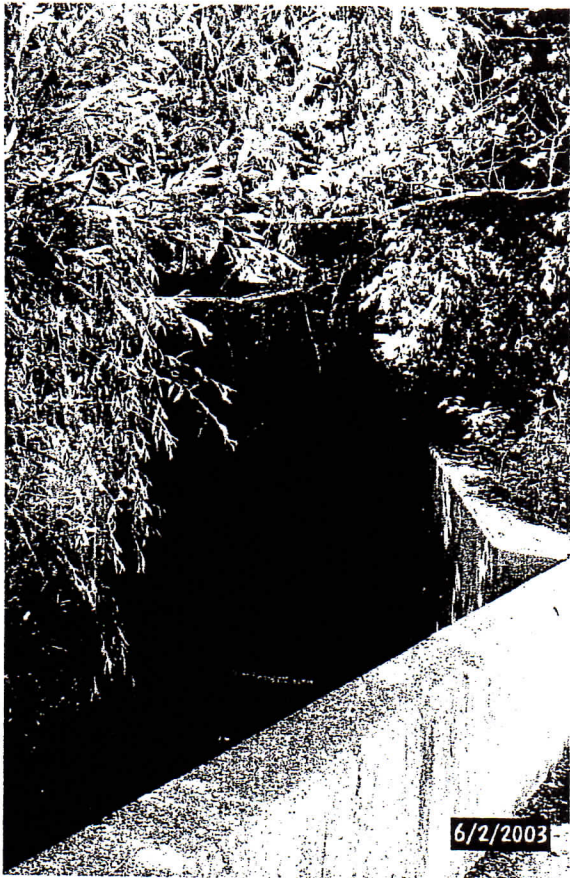
Photo 1: Sample Location SW-11
Morehall Rd. Tributary at Lancaster Ave.

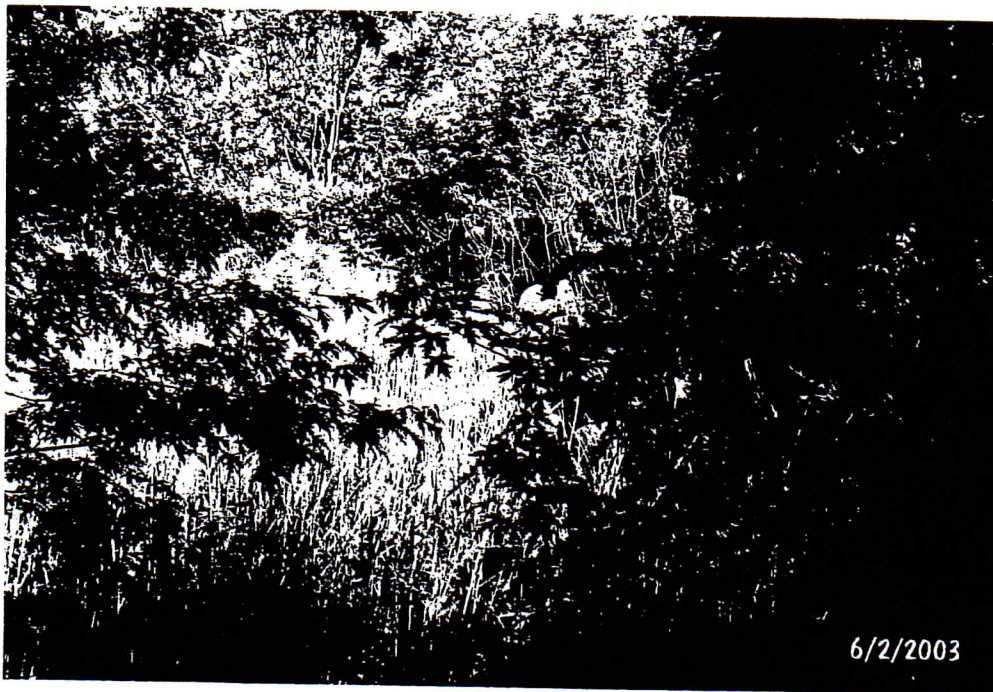
Photo 2: Sample location SP-3 near extended stay hotel.

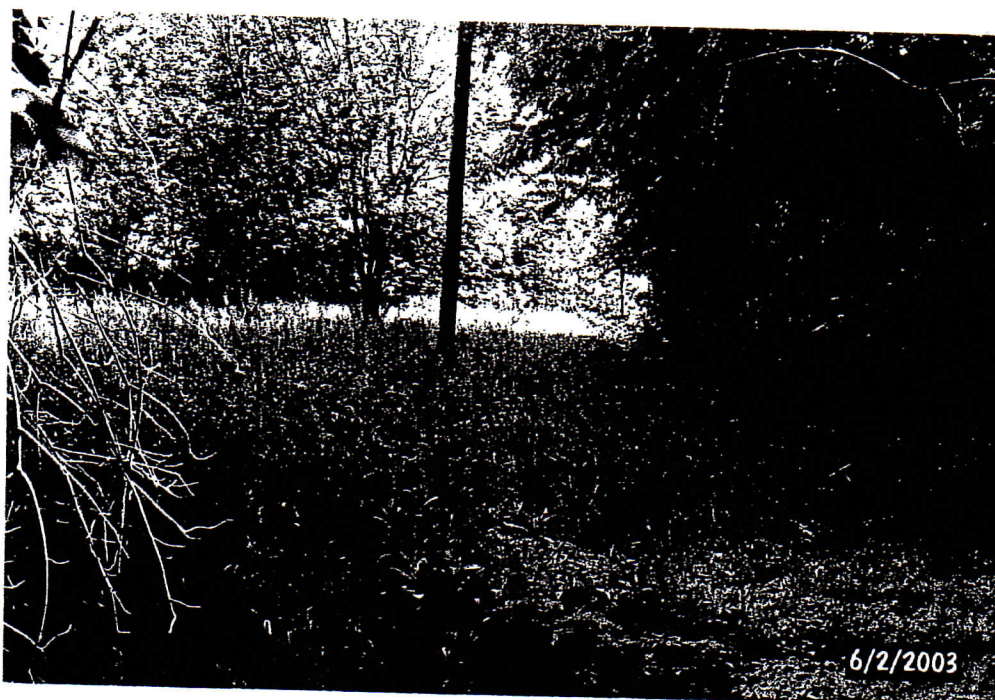
As noted above, TCE was detected in each of the springs sampled during this event. Concentrations ranged from a low of 0.23 ug/L at SE-1 (just upgradient of the source area) to 150 ug/l at SP-4B (wetlands discharge area between Morehall Rd. and the former Worthington Steel property). SP-4 is the most significant spring directly entering Little Valley Creek in the study area. A springhouse marks the origin of SP-4, but a large wetland area is located just to the north of the springhouse and apparently results from a large area of groundwater discharge. Lower concentrations of TCE were detected in samples SP-3 and SE-1. SP-3 was collected from a fragmities wetland area located adjacent to the Summerfield Suites Hotel (20 Morehall Rd.). This spring enters the Morehall tributary of Little Valley Creek just below Lancaster Avenue. SP-3 contained TCE at a concentration of 6.5 ug/L. This sample was the only sample collected in the event found to contain Chloroform and Bromodichloromethane. These VOCs are in a group of compounds called trihalomethanes, which are chlorination byproducts. This spring is located near a swimming pool associated with the hotel. A very low concentration of TCE (0.23 ug/L J) was detected in sample SE-1, which was collected on the Bishop Tube property, just upstream from the manufacturing facility. This detection may be the result of chemical diffusion from the drum storage area, the nearest source area at the site.

Photo 4: Sample location SP-4B. Spring area in wetland near Norwood Industries facility.
